# Manhole Inspection Summary

Manhole # S37E\_\_041MH

Insp Date: **7/20/09 10:48 AM**

**Location** Address: **601 E. Fayette St**

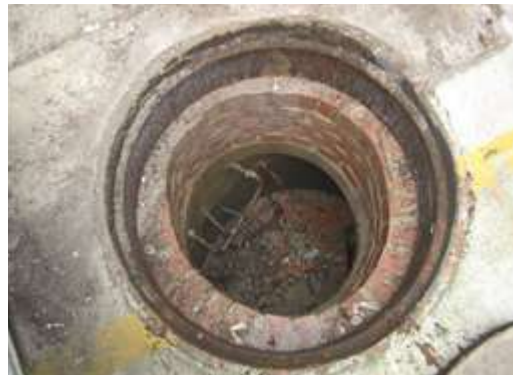
Frame View

Comments **Located at Police Precinct; Fframe and cover too big for MH. Deep slope in channel, the reason for the huge difference in inverts.**

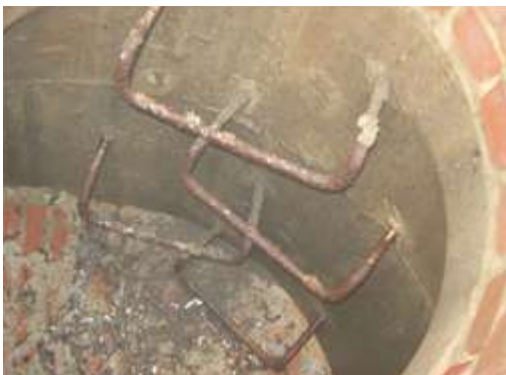
Defect 1

**Steps** Count: **0** Missing: **0** ☒ **Corroded**

corroded rungs

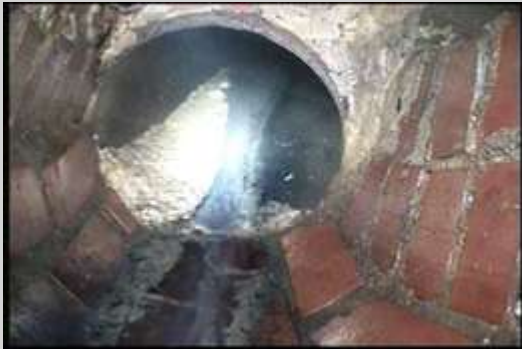
12 O'Clock Outflow

10 in. Circular Gravity Sewer  
Pipe Out @ 12 O'Clock

Pipe Height: **9.6** (in.) Rod and Bar (Angled)  
Pipe Material: **Clay** ☐ Pipe Lined  
Invert Depth: **7.80** (ft.) Flow Characteristics: **None**  
Deposits: ☒ None ☐ Mud ☐ Sludge ☐ Debris ☐ Grease  
Silt Depth: **0** (in.) Deposits Extent:  
Infiltration: **None** Pipe Seal Cond: **Sound**

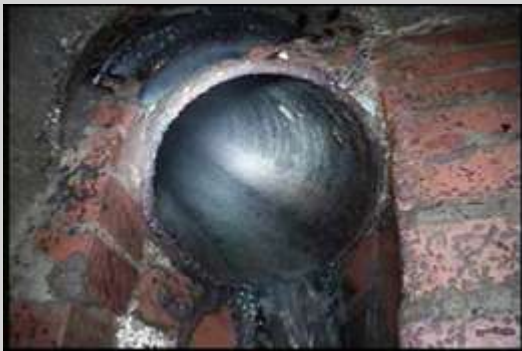
6 O'Clock Inflow

8 in. Circular Gravity Sewer  
Pipe In @ 6 O'Clock

Pipe Height: **7.2** (in.) Rod and Bar (Angled)  
Pipe Material: **Clay** ☐ Pipe Lined  
Invert Depth: **6.48** (ft.) Flow Characteristics: **Slow**  
Deposits: ☒ None ☐ Mud ☐ Sludge ☐ Debris ☐ Grease  
Silt Depth: **0** (in.) Deposits Extent:  
Infiltration: **None** Pipe Seal Cond: **Sound**
